## An original Approach to Retrofitting A Post and Core Restoration to an Existing bridge

**Citation:** Debbabi Imen, Saafi Jilani, Noura Zohra, Harzallah Belhassen, Cherif Mounir (2018) An original Approach to Retrofitting- A Post and Core Restoration to an Existing bridge. J Oral Health Dent Sci 2: 202

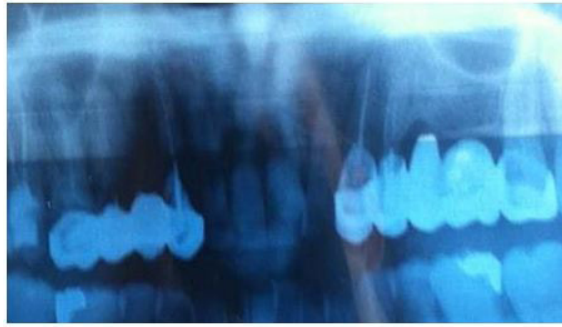
**Figure 1:** Panoramic radiography

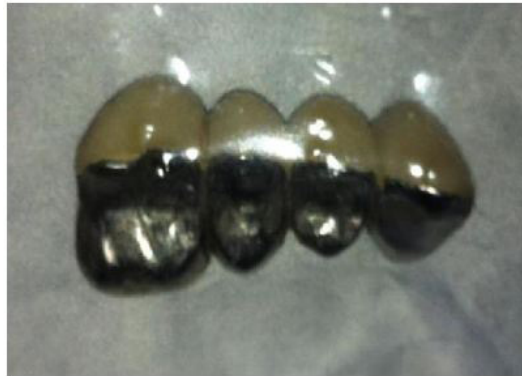
A 46-year healthy female presented to the department of fixed prosthodontics at the dental clinic of Monastir in emergency to recement her veneered bridge. The bridge has 3 retainers on canine #13, second premolar #14 and first molar #16 and a pontic replacing the first premolar #14. It was loosened partially on the side of the canine. It was very mobile but in good condition. According to the patient, the bridge dates from 6 years. Moreover, the patient sought for a quick and urgent aesthetic and functional solution. The patient brought with her an old panoramic X-ray (Figure 1). The bridge was very mobile that's why it was easily and completely removed by the Manual Crown and Bridge Remover which was fixed in the palatal side to avoid the detachment or the fracture of the veneering buccal surfaces. The bridge does not present any cracks after the use of crown remover (Figure 2).

**Figure 2:** Bridge was removed

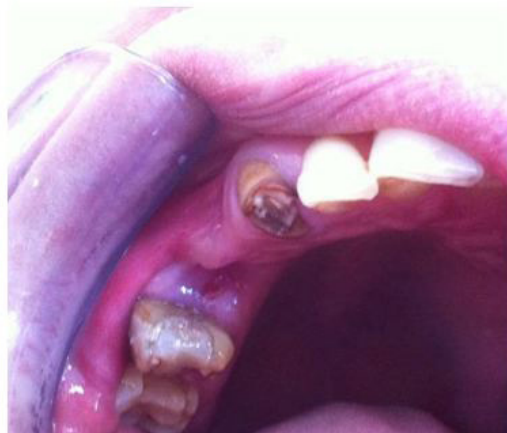
Clinical examination of the abutments teeth showed that the canine was dilapidated. Its decay is supragingival. At the level of the tooth persists a screw post which has been unscrewed using a Classic smooth flat pliers. The #15 remained as a root tip with softened walls and a very deep caries. Its prognosis is unfavorable so we decided to extract it. The #16 exhibited extensive restoration with composite resin (Figure 3). Occlusion exam revealed a stable maximum intercuspation.

**Figure 3:** Clinical examination of the abutments after debridement of the old bridge and the extraction of the 15

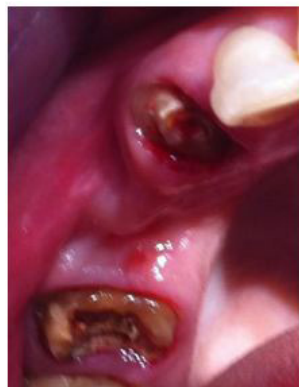
Radiographic evaluation demonstrated an excellent bone support for the remaining teeth #13 and #16 [7]. The canine and molar are properly treated endodontically with acceptable treatment and sufficient remaining coronal tooth structure. The Eatch abutment tooth was thoroughly investigated and residual caries, and existing restoration and cement were removed [8]. The finish lines of the two teeth (#14 and #16) were preserved after peripheral preparation (Figure 4).

**Figure 4:** The finish lines of the two teeth (#14 and #16) are preserved after peripheral preparation

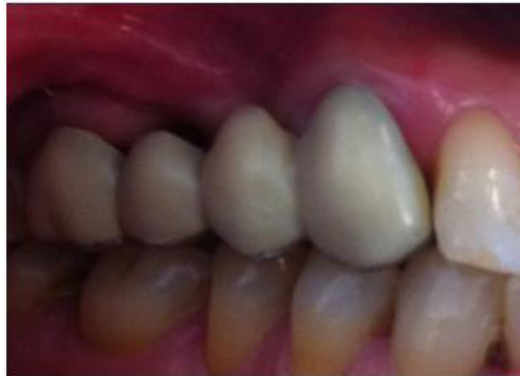
In this case, the pontic is above the gum – which makes it very easy to clean using interdental brush. The problem in this option is that there is a very noticeable gap between gum and pontic, which is not pleasant to look at (Figure 5). Thankfully, the gap is not visible when smiling so it does not cause an aesthetic problem for the patient to whom the situation has been explained (Figure 6). The patient asked to use the old bridge as a quick and temporary solution.

**Figure 5:** Noticeable gap between gum and pontic

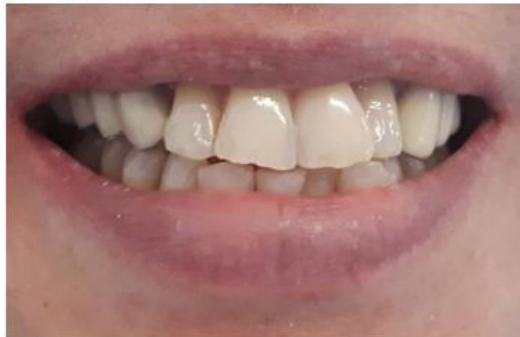
**Figure 6:** The gap is not visible when smiling

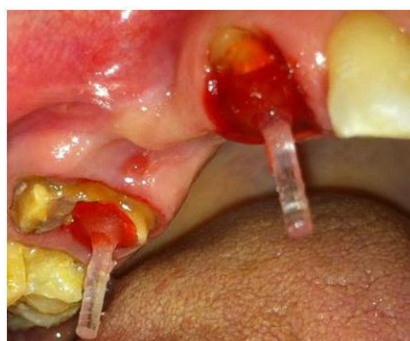
**Figure 7:** The plastic posts were rebazed with duralay resin

The healing of the gum related to the socket was well improved. After selecting an appropriate size of plastic posts (Para-Post, Whaledent International, New York, N.Y.), they were inserted into the prepared root canals. The plastic posts were rebazed by Coating the post with an autopolymerizing acrylic resin material (Duralay, Reliance Dental Mfg Co, Alsip, Ill.) to ensure better adaptation to the teeth structure (post in post space of #13 and the palatal post space of the #16) (Figure 7). The length of the post were adjusted by cutting them with a disk so they do not interfere with the inner surfaces of the retainers which can jeopardize accurate seating and appropriate occlusion (Figure 8).

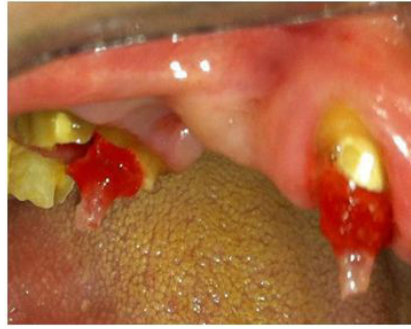
**Figure 8:** The posts are cut

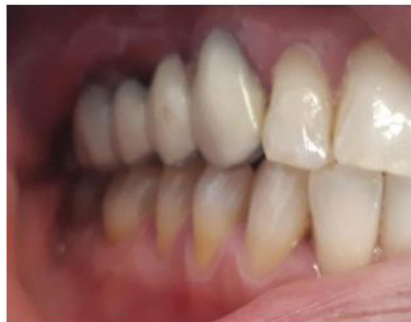
**Figure 9:** The bridge is tried in maximum intercuspation

A layer of lubricant was applied in each inner surface of retainers and to the teeth structures to facilitate the desinsertion of the bridge after the setting time of the resin. The bridge is tried in maximum intercuspation (MI) (Figure 9).

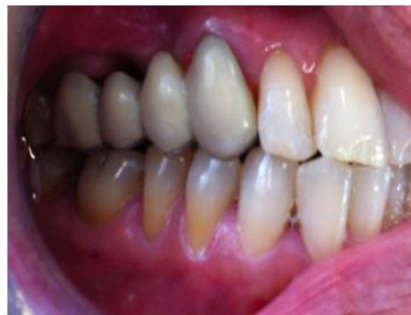
**Figure 10:** The patient was asked to close in the position of maximum intercuspation (MI)

The duralay resin material was then mixed and filled in the inner surfaces of the retainers, then placed over the plastic posts and the patient was asked to close in the position of maximum intercuspation (MI) to avoid sur-occlusion until the resin material completely polymerizes then removed (Figure 10).

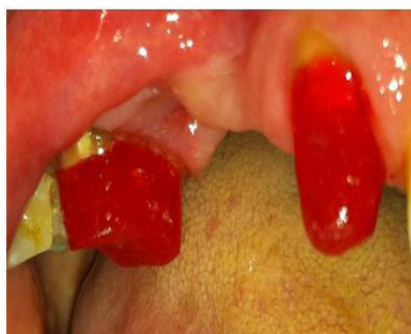
**Figure 11:** Models of 2 casted post and core after refining

The refabricated Duralay posts and cores were checked so that there was no deficiency of the material and that the contour of the previous cast post and core was reproduced and excessive core material may remain over the margin was removed using a probe. The setting time of the Duralay resin is 5 min. the models of 2 posts and cores were refined using dental diamond bur on turbine under irrigation to create additional cement space between the abutments and the retainers, then sent to the laboratory to be casted in metal (Figure 11,12 and 13) [5]. Obviously at this step adding grooves or boxes to the refabricated duralay post and core (new abutments) limits the paths of placement, so retention is increased [9].

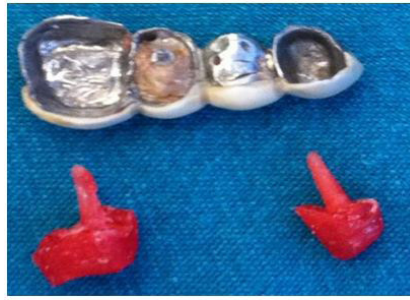
**Figure 12:** Old bridge with two models of two duralay posts and cores

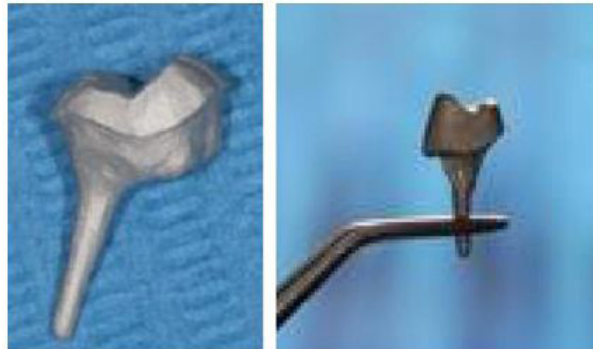
**Figure 13:** The models of 2 posts and cores casted in metal

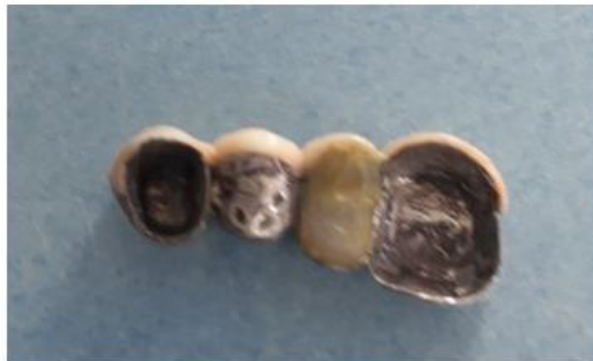
**Figure 14:** Light cure composite resin filled in the inner surface of tooth #15

In the lab, the fitting surface of retainer on # 15, already extracted, was cleaned and most effectively prepared by air-abrading with 50mm of alumina and in the clinic it was filled with a light cure composite resin to be transformed into Pontic (Figure 14).

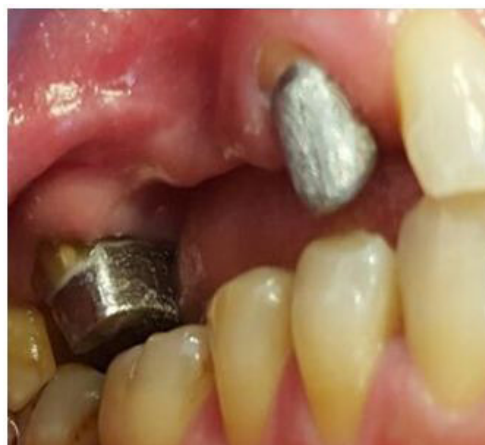
**Figure 15:** The 2 casted post and core are cemented

The casted posts and cores were tried in the mouth without the bridge to ensure their perfect adaptation, then in a second time with the bridge in situ to assess the absence of over-occlusion. Finally, they were cemented with adhesive glass ionomere cement (Figure 15). In the last time, the bridge is cemented using zinc phosphate cement (Figure 16).

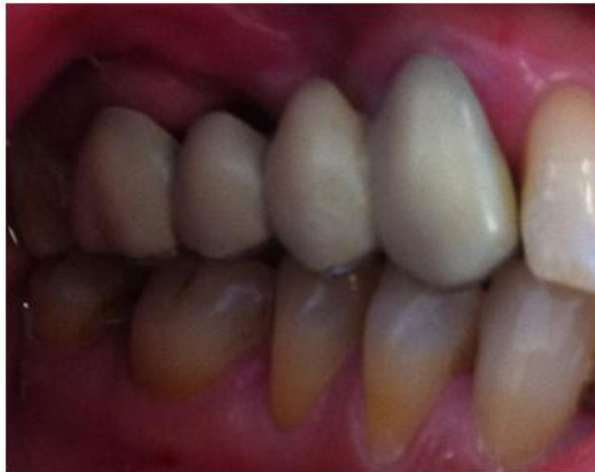
Figure 16: The bridge was cemented
