Microleakage at Implant-Abutment Interface in Internal Conical Connection Implants, an *In-Vitro* Study

Buitrago-Osuna A^{1*}, Espinel-Ramos JA¹, Henao-Riveros SC², Sarmiento-Delgado ML¹

¹Oral Health Department, National University of Colombia, Bogota Campus, Colombia

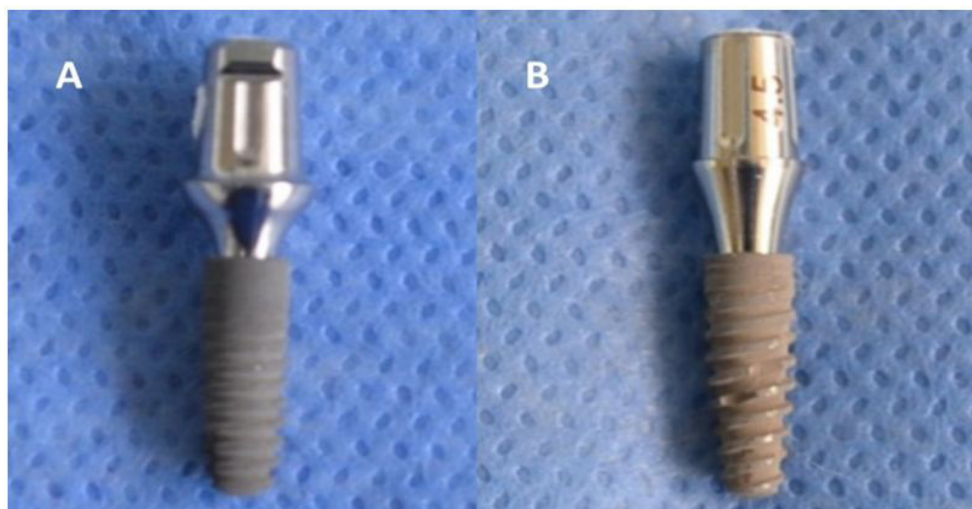
Figure 1: Two Groups of Study

A) Ankylos 3.5 x 11mm, standard abutment

B) Neodent 3.5 x 11mm standard abutment

Ten implant- abutment systems were used in this *in vitro* study. They were divided in two groups: Group 1, Ankylos (3.5 x 11mm. Dentisply-Friadent, Mannheim, Germany) and Group 2 Neodent. Drive CM (3.5 x 11mm Neodent- Curitiba Brasil) each one with its respective standard abutment. (Ankylos regular abutment/x GH3.0) (Neodent universal abutment CM exact)

The abutments were assembled according to the manufacturer recommendations: Ankylos 15N.cm., Neodent 15N.cm. To evaluate the microbial detection techniques two Implant-Abutment replica were used [18]. As a positive control: implant system replica without assembled abutment submerged in contaminated BHI; negative control: implant system replica without assembled abutment submerged in sterile BHI (Figure 1).

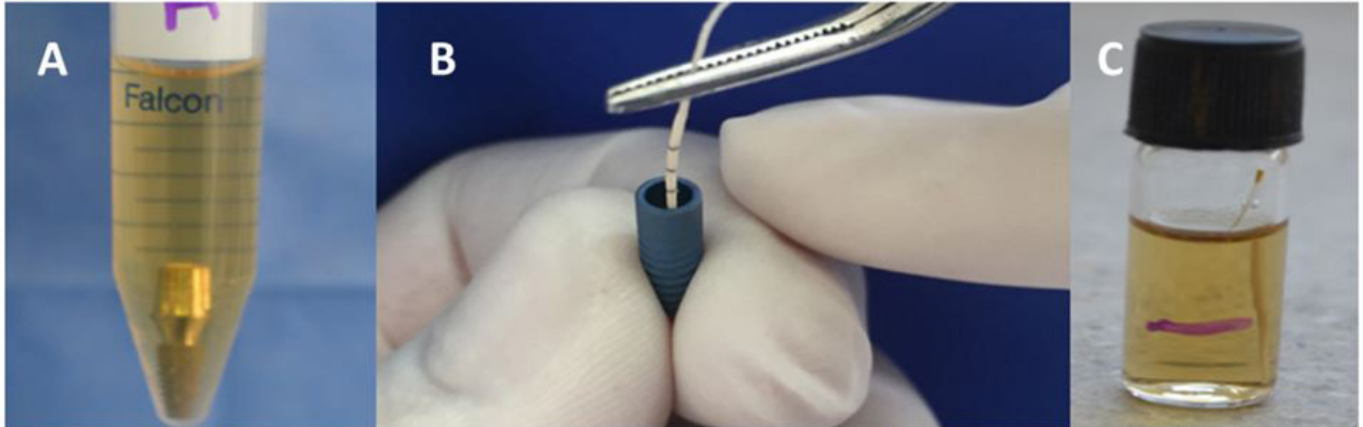
Figure 2: Experimental Phase

- A. Implant abutment complex submerged in BHI broth
- B. The sample was taken from the inner part of the implant
- C. Sample of negative control submerged in BHI broth

The *E. coli* ATCC 35218 was cultured in MacConkey medium for 24 hours at 37 °C. The BHI broth was inoculated to obtain a bacterial concentration at 0.5 scale of MacFarland (1×10^8 colony forming units per ml) - absorbance between 0, 8-1.1 and 625 Nm [19]. The assemblies were placed into test tubes containing 5ml of contaminated BHI. They were cultured at 37 °C for 36 hours (Figure 2).

After 36 hours, the implants were removed from the test tubes and cleaned with 80% alcohol for 3 minutes and dried with sterile gauze to avoid external contamination. This procedure guaranteed external sterility without affecting the internal cell viability [20].

The abutments were removed from the implants. To minimize the possibility of contamination, the disconnection and the sampling from the inner portion of the implant with sterile paper cones were performed by two different people [21].

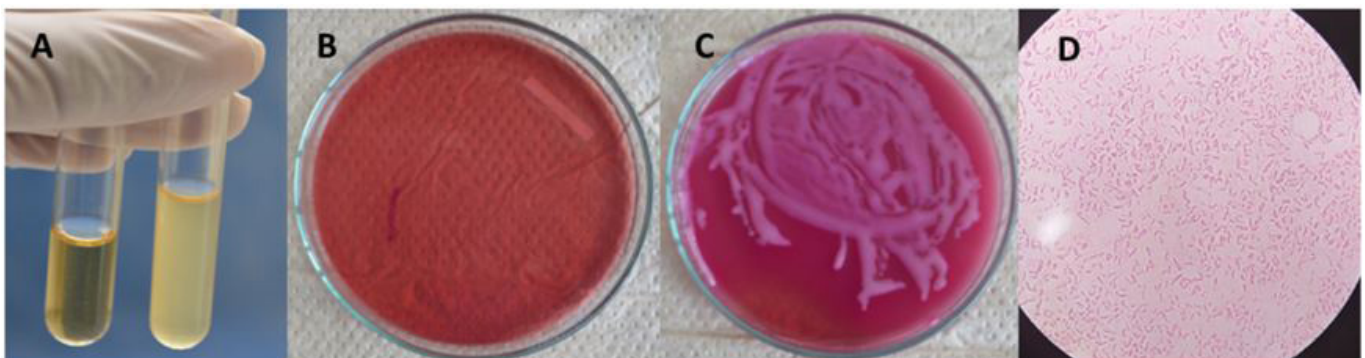
Figure 3: A. MacFarland Scale. Left tube scale 0, right tube scale 5

- B. Colony forming unit, negative control without UFCs
- C. The culture medium (positive control) uncountable UFCs
- D. Gram stain. It was possible to confirm that there were gram negative bacilli compatible with *E. coli*

The paper cone to be used was immersed in 2 ml of sterile BHI and brought to 37 °C during 24 hours. The turbidity of the medium was observed (yes / no), a Mac Farland scale was allocated according to the degree of turbidity, and later measured by spectrophotometry. Finally, 15 μ l were taken and cultured in MacConkey agar for 24 hours at 37 °C for further 24 hours to perform the UFC count. At last, the presence of *E. coli* was confirmed by gram staining (Figure 3).

To validate the detection techniques, the same treatment of the samples was carried out for the positive and negative controls. The data evidence that the filtration and collection conditions of the samples were carried out adequately. The positive control remained positive and the negative control remained negative. The filtration was evaluated qualitatively and semi-quantitatively. This procedure proved that in a dichotomous visual scale (yes / no), MacFarland scale, and spectrophotometry there was no evidence of bacteria in any implant. When carrying out the evaluation by means of CFUs, a Neodent implant presented a colony forming unit. When performing gram stains, it was possible to determine that the microorganisms were gram-negative bacilli. The results are shown in Table 1.
